Appendix E. Other Supporting Information

ST. MARY CANAL

WATER LOSS ASSESSMENT

Prepared by
Farmers Conservation Alliance

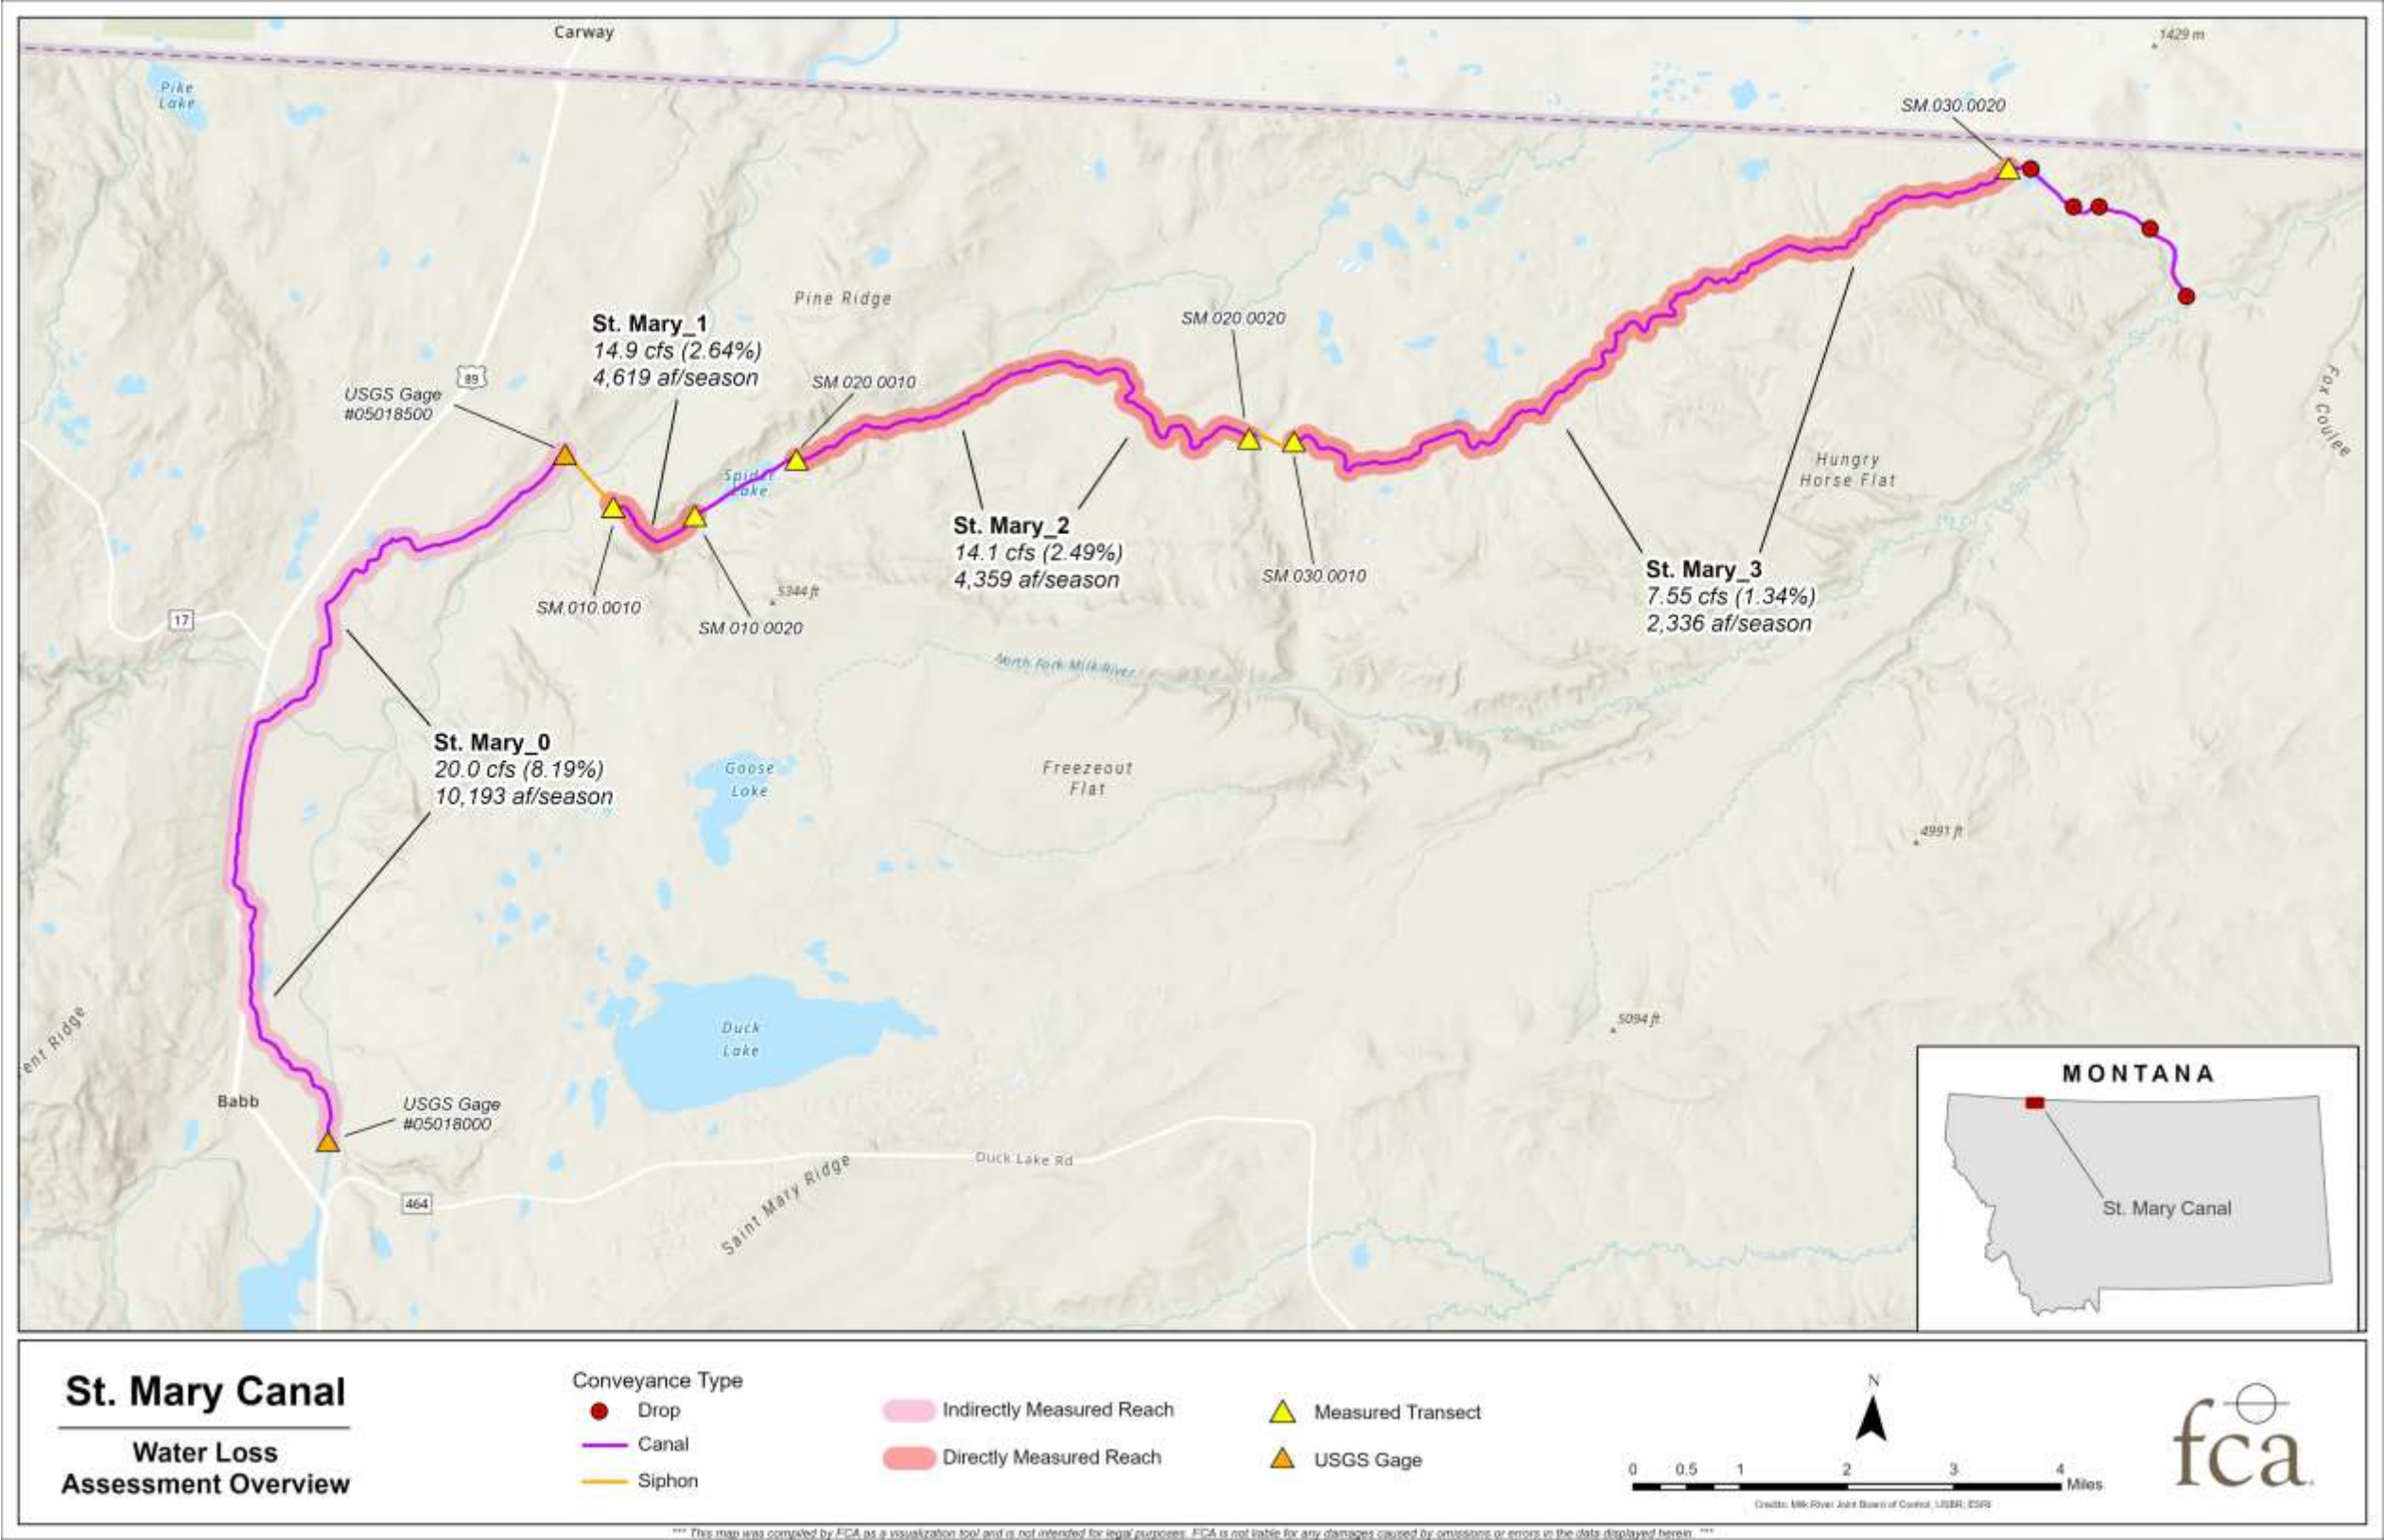
Figure 1-1. Seepage Sub-Reach Locations on St. Mary Canal, June 26-28, 2021.

Farmers Conservation Alliance (FCA) completed a water loss assessment on the St. Mary Canal between June 26 and June 28, 2021. The purpose of this assessment was to determine the potential water losses within the District's earthen canals due to subsurface infiltration, evaporation, plant and tree transpiration, or a combination of such factors, which could represent potential water savings. In addition, FCA performed an analysis of 11 years of streamflow gage data for the Upper St. Mary Canal, from the diversion dam to the St. Mary Siphon intake. These data were used to compute mean and median canal losses between Water Year (WY) 2006 and WY 2016 using the upstream and downstream USGS gages. FCA selected an assessment timeframe to coincide with near maximum diversion rates during the irrigation season, to assess losses at close to peak diversions, and to avoid uncertainty related to changes in irrigator demands that are difficult to quantify within the selected reaches of each ditch. Matt Melchiorson, FCA Hydrologist, selected discharge measurement locations prior to data collection to identify and measure known losing reaches. US Bureau of Reclamation Engineer, Steve Darlinton, was also instrumental in planning the study, sharing his knowledge of the system with the team, and assisting with logistics. Figure 1-1 identifies the reaches and transects, along the St. Mary Canal that were included in this assessment.

To estimate the instantaneous losses associated with seepage on the Lower St. Mary Canal, FCA measured a total of three sub-reaches from the St. Mary Siphon outfall to just above Drop #1. These sub-reaches represent most of the Canal length below the first siphon. The remainder of the conveyances below the drops were not included, due to either time constraints or because they are natural river conveyances. Because no deliveries exist on the Upper St. Mary Canal between two USGS gages, no direct measurements were necessary to assess seepage in that reach, as described in Section 2.2.2.2.

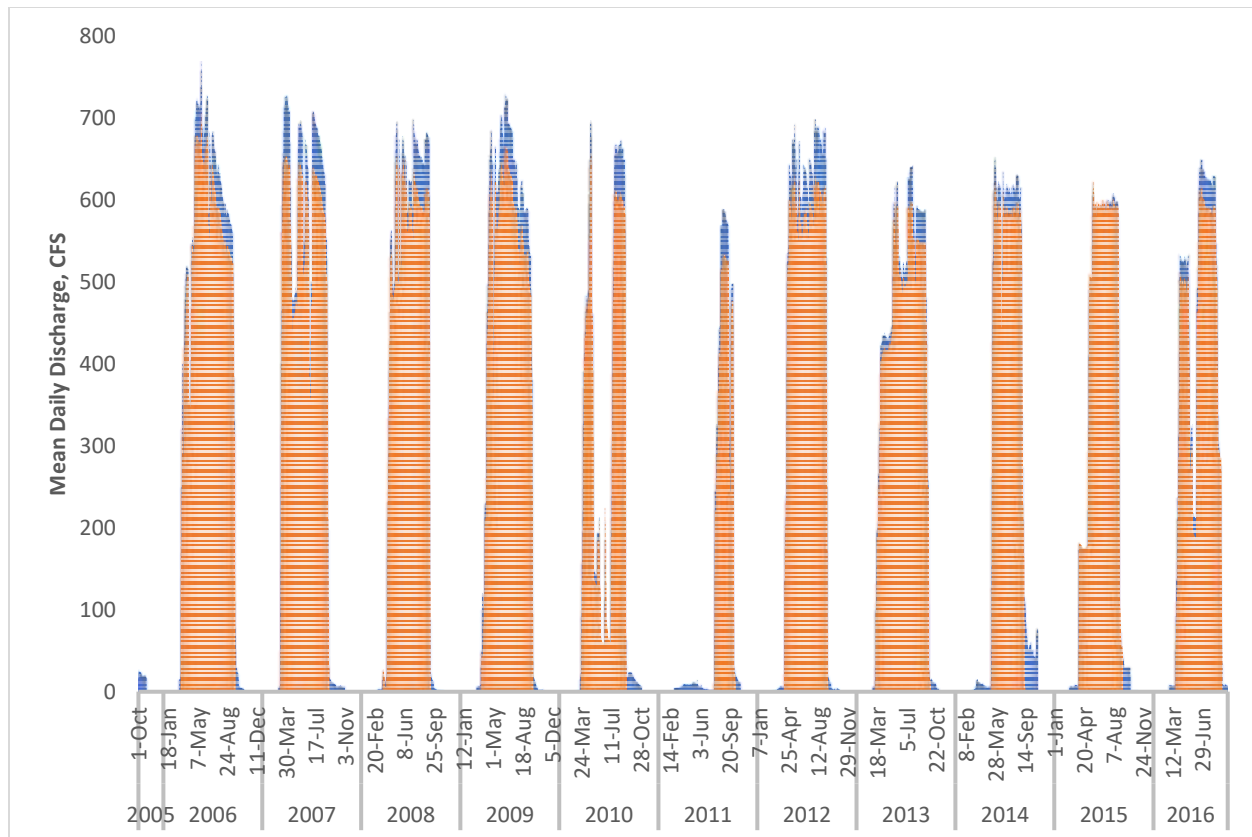
Figure 3-1. Upstream (blue) vs. Downstream (orange) Daily Flows in Upper St. Mary Canal, WYs 2006-2016.

As was also discussed in Section 2, 11 years of historic data were analyzed from the upstream and downstream gages on the Upper St. Mary Canal, above the St. Mary Siphon intake. Based on differences between the upper gage (USGS #05018000) and the lower gage (USGS #05018500), theoretical losses for WYs 2006-2016 were computed. Annual losses ranged from 3,614 ac-ft during WY 2015 to 18,655 ac-ft during WY 2009. The large variation in annual losses is believed to be a product of the magnitude of diversion flow rates, weather variables, and the duration of diversions year over year. Higher diverted flow rates over a longer season typically resulted in greater overall seepage amounts. The mean and median loss volumes over the 11-year analysis period are presented in Table 3-4. Mean daily flow from both gages for individual years, in cfs, are also presented graphically in Figure 3-1 below.

In addition, an analysis of historic USGS gage data from October 1, 2005 to September 30, 2016 indicated mean losses of 11,306 ac-ft, and median losses of 10,193 ac-ft in the Upper St. Mary Canal from the diversion dam to the St. Mary Canal Siphon intake. Analysis of individual years in the same time period indicated losses ranging from 3,614 ac-ft to 18,655 ac-ft, associated percent losses ranged from 2 percent to 12 percent, with mean and median losses computed at 7 percent.

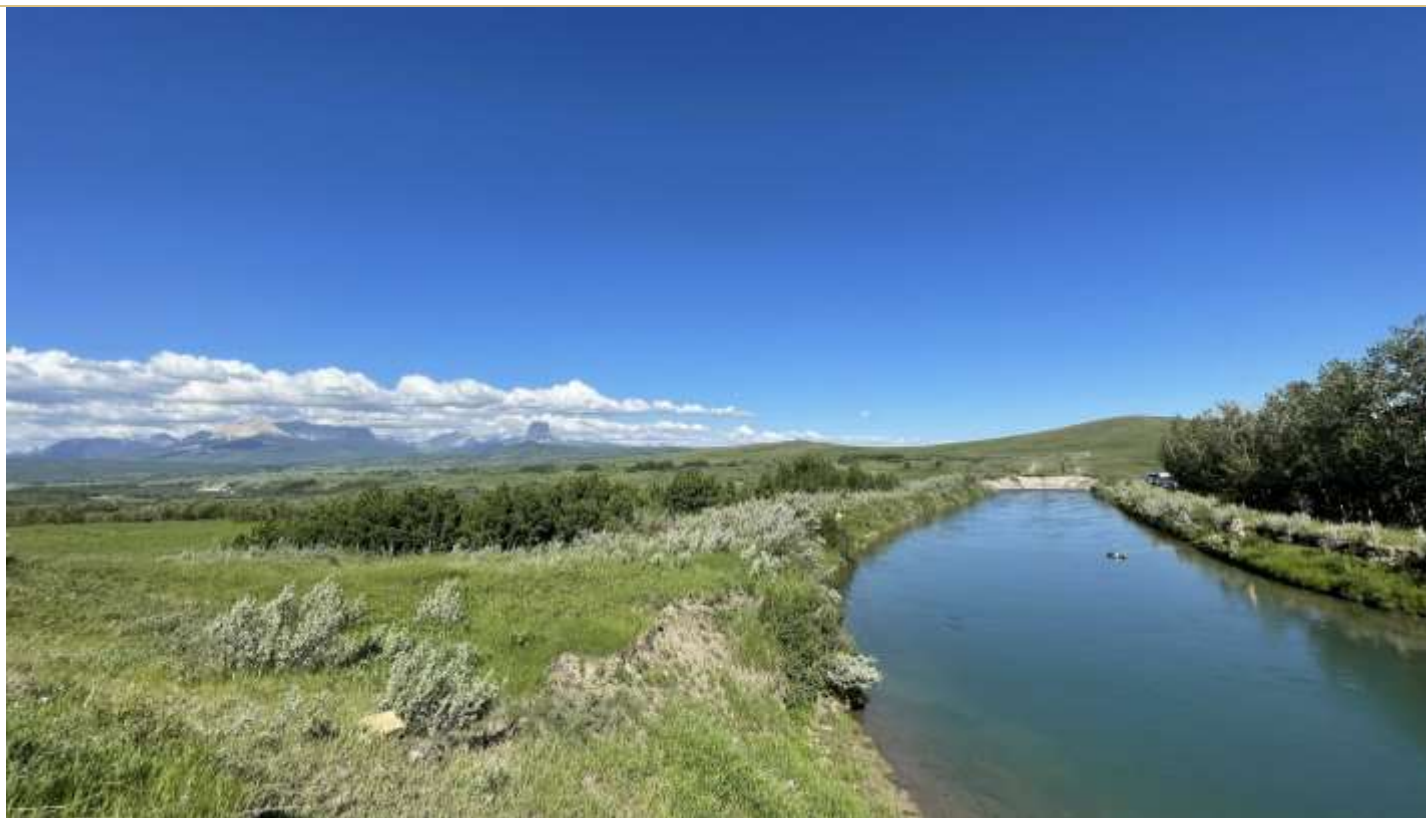
PHOTO 1. TRANSECT SM.010.0010 ON THE ST. MARY CANAL, JUNE 26, 2021

<i>Location Description</i>	Approximately 200 feet below the St. Mary Canal Siphon outfall
<i>Geographic Coordinates</i>	48° 56' 23.85" N 113° 21' 53.49" W
<i>Cross-Section Description</i>	Silt/clay and cobble trapezoidal canal, with good velocity distribution throughout the cross section
<i>Stability Monitoring</i>	A reference gage (OSS) and recorder data are available at the streamflow gage near the St. Mary Siphon intake; steady-state conditions were verified by stable recorded gage heights of 7.56 feet during the four ADCP measurements.
<i>Reach Characteristics</i>	The ditch downstream from the transect location comprised primarily cobbles set in soil. Bank vegetation consisted of moderate emerging grasses and established riparian vegetation. The location was selected to quantify baseline inflow to the St. Mary Canal sub-reach 1.
<i>CMM#1-4 (cfs)</i>	612, 622, 581, 618
<i>Mean Discharge (cfs)</i>	608

<i>Accuracy Rating</i>	Measurements field rated good (+/- 5%)

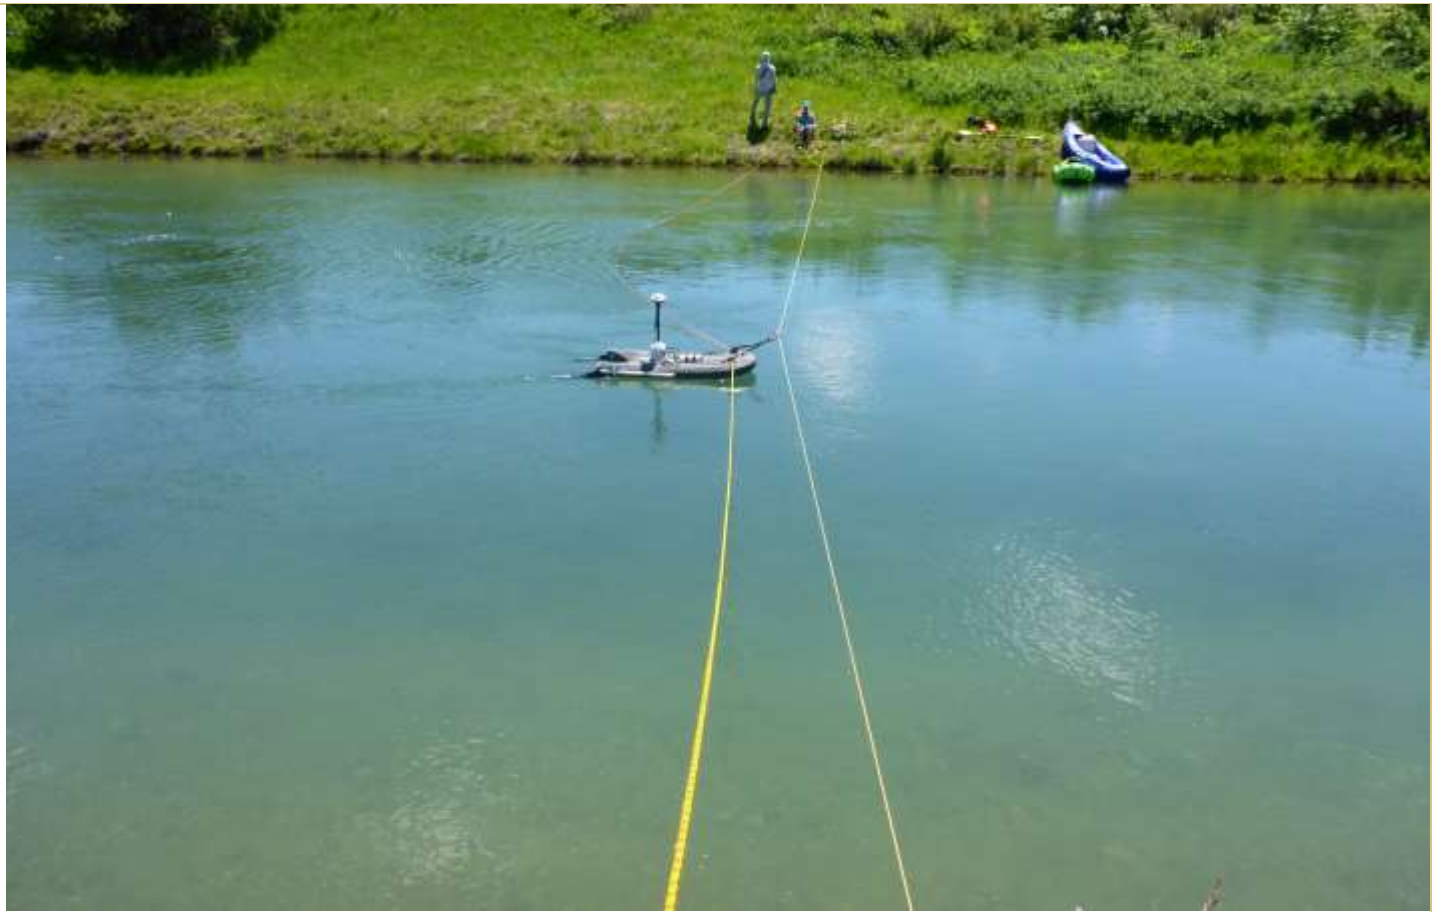
PHOTO 2. TRANSECT SM.010.0020 ON THE ST. MARY CANAL, JUNE 26, 2021

<i>Location Description</i>	Approximately 1000 feet upstream from where Spider Lake causes the Canal to go into backwater
<i>Geographic Coordinates</i>	48° 56' 22.51" N 113° 20' 51.92" W
<i>Cross-Section Description</i>	Cobbles set in soil, good depth and velocity distribution in cross section, no submerged vegetation noted
<i>Stability Monitoring</i>	A reference gage (OSS) and recorder data are available at the streamflow gage near the St. Mary Siphon intake; steady-state conditions were verified by stable recorded gage heights of 7.56 feet during the four ADCP measurements.
<i>Reach Characteristics</i>	The ditch both upstream and downstream from the transect location comprised primarily cobbles set in soil. Bank vegetation consisted of moderate emerging grasses and established riparian vegetation. The location was selected to close out the loss assessment on St. Mary Canal sub-reach 1.
<i>CMM#1-4</i>	586, 593, 589, 600

<i>Mean Discharge (cfs)</i>	592
<i>Accuracy Rating</i>	Measurements field rated good (+/- 5%)

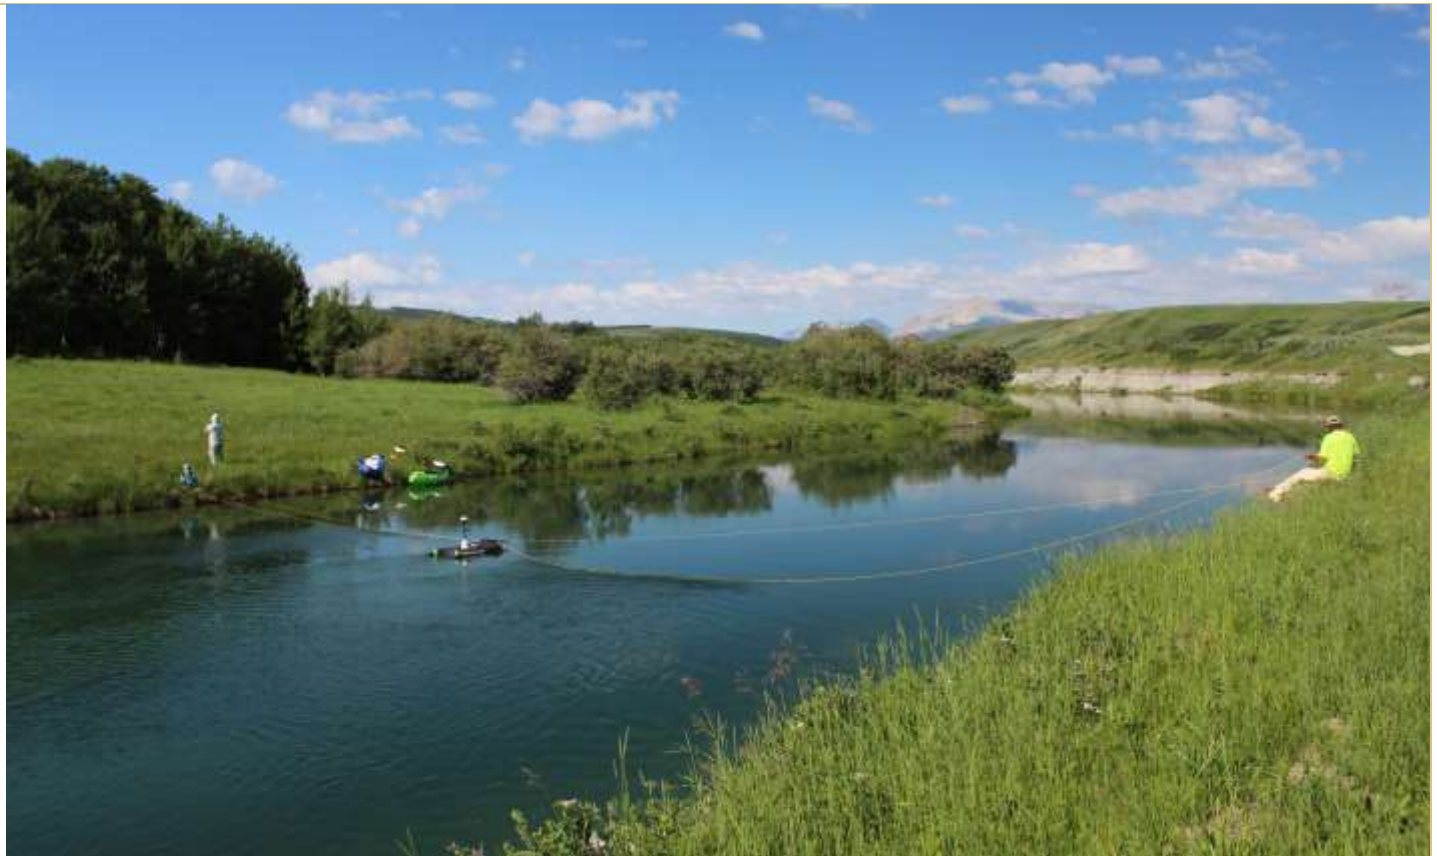
PHOTO 3. TRANSECT SM.020.0010 ON THE ST. MARY CANAL, JUNE 27, 2021

<i>Location Description</i>	Approximately 800 feet below the outlet of Spider Lake
<i>Geographic Coordinates</i>	48° 56' 51.76" N 113° 19' 39.86" W
<i>Cross-Section Description</i>	Cobbles set in soil, good depth and velocity distribution in cross section, no submerged vegetation noted; wide with a smooth water surface
<i>Stability Monitoring</i>	A reference gage (OSS) and recorder data are available at the streamflow gage near the St Mary Siphon intake; steady-state conditions were verified by stable recorded gage heights of 7.54 feet during the four ADCP measurements.
<i>Reach Characteristics</i>	The ditch upstream and downstream from the transect comprised primarily cobbles set in silt/clay. Bank vegetation consisted of thick grasses. The location was selected to quantify baseline inflow into sub-reach 2 on the St. Mary Canal.
<i>CMM#1-4 (cfs)</i>	600, 598, 603, 611
<i>Mean Discharge (cfs)</i>	603

<i>Accuracy Rating</i>	Measurements field rated good (+/- 5%)

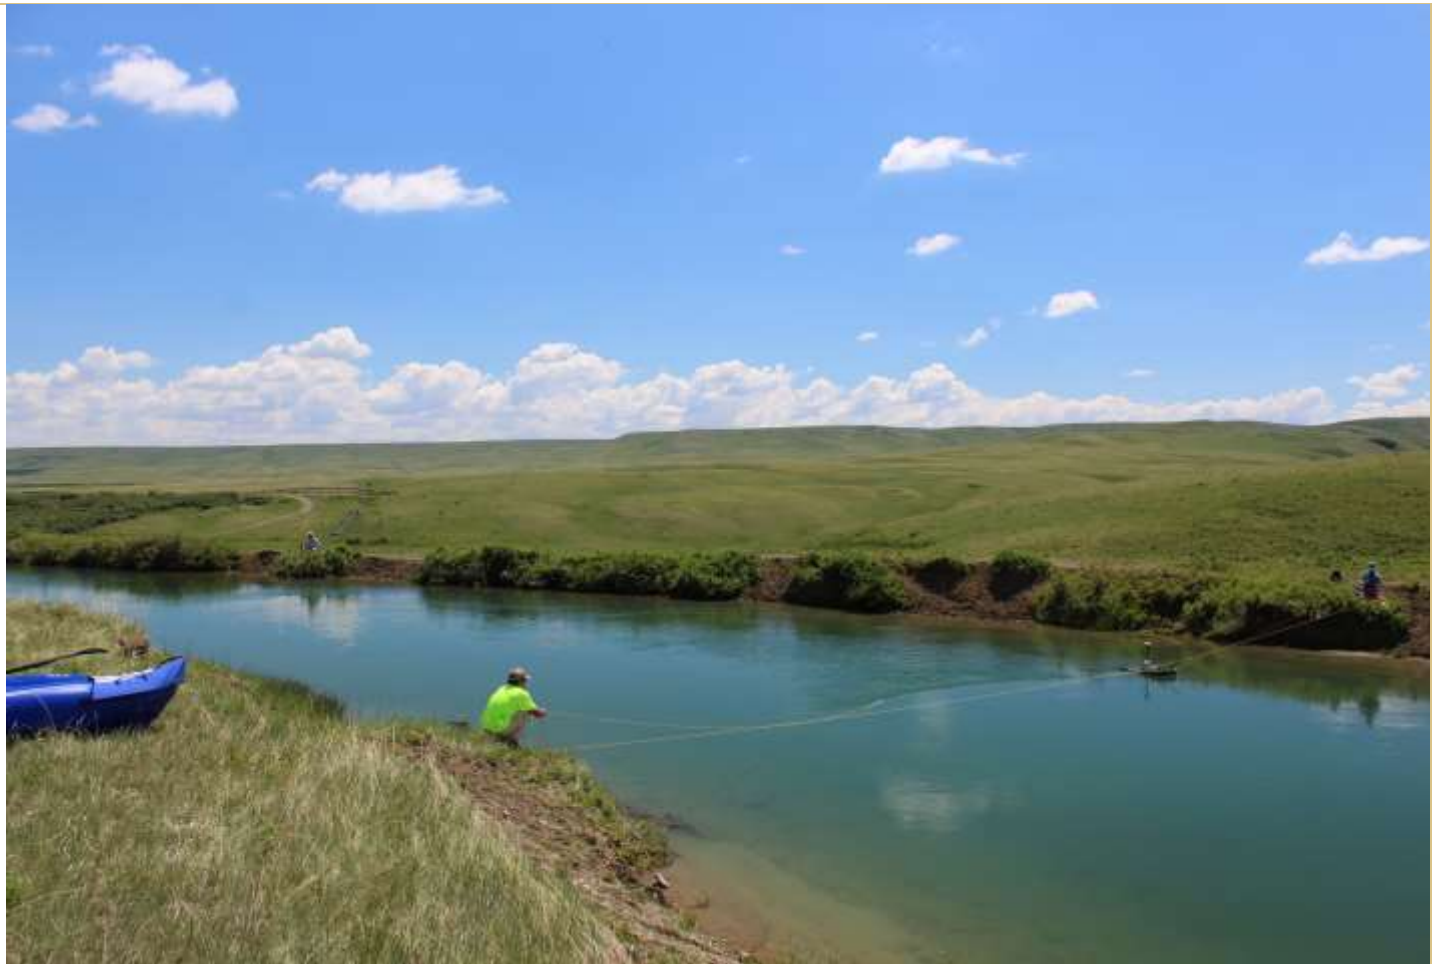
PHOTO 4. TRANSECT SM.020.0020 ON THE ST. MARY CANAL, JUNE 27, 2021

<i>Location Description</i>	Approximately 200 feet upstream from the Halls Coulee Siphon intake
<i>Geographic Coordinates</i>	48° 57' 12.80" N 113° 14' 6.27" W
<i>Cross-Section Description</i>	Cobbles set in soil, good depth and velocity distribution in cross section, no submerged vegetation noted; wide with a smooth water surface and minor angles
<i>Stability Monitoring</i>	A reference gage (OSS) and recorder data are available at the streamflow gage near the St. Mary Siphon intake; steady-state conditions were verified by stable recorded gage heights of 7.54 feet during the four ADCP measurements.
<i>Reach Characteristics</i>	The ditch upstream and downstream from the transect location comprised primarily silts and clay. Bank vegetation consisted of sparse grasses. The location was selected to close out the loss assessment on sub-reach 2 of the St. Mary Canal.
<i>CMM#1-4 (cfs)</i>	583, 610, 575, 585

<i>Mean Discharge (cfs)</i>	588
<i>Accuracy Rating</i>	Measurements field rated good (+/- 5%)

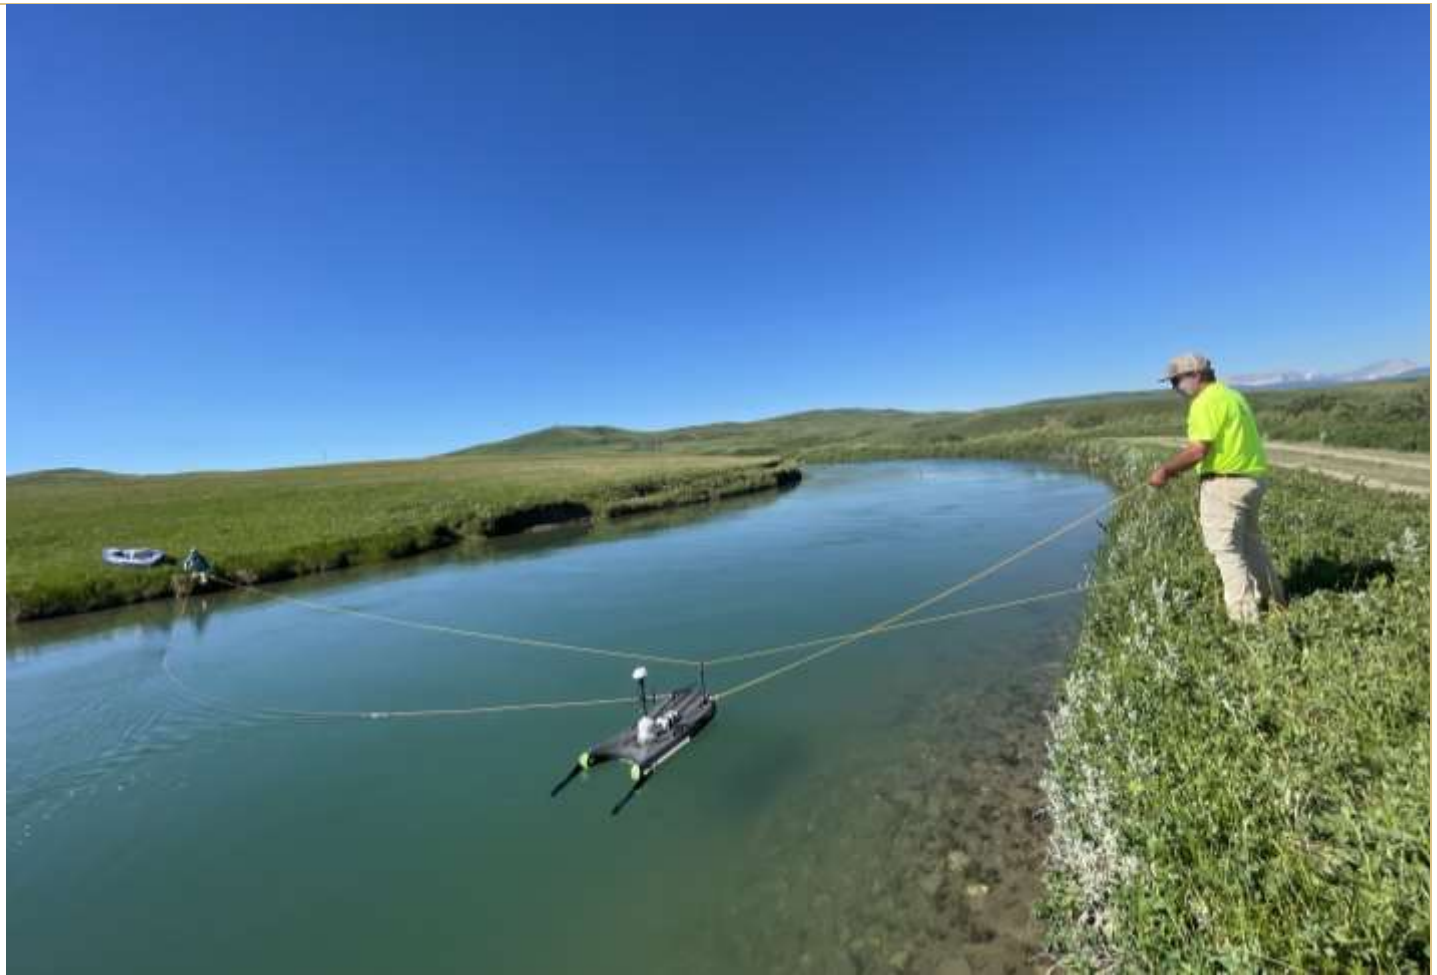
PHOTO 5. TRANSECT SM.030.0010 ON THE ST. MARY CANAL, JUNE 28, 2021

<i>Location Description</i>	Approximately 600 feet downstream from the Halls Coulee Siphon outfall
<i>Geographic Coordinates</i>	48° 57' 12.19" N 113° 13' 33.10" W
<i>Cross-Section Description</i>	Cobbles set in soil, good depth and velocity distribution in cross section, no submerged vegetation noted; narrower, with a smooth water surface
<i>Stability Monitoring</i>	A reference gage (OSS) and recorder data are available at the streamflow gage near the St. Mary Siphon intake; steady-state conditions were verified by stable recorded gage heights of 7.53 feet during the four ADCP measurements.
<i>Reach Characteristics</i>	The ditch upstream and downstream from the transect location comprised primarily cobbles set in silt/clay. Bank vegetation consisted of sparse grasses. The location was selected to establish baseline inflow into sub-reach 3 of the St. Mary Canal.
<i>CMM#1-4 (cfs)</i>	599, 579, 619, 580

<i>Mean Discharge (cfs)</i>	594
<i>Accuracy Rating</i>	Measurements field rated good (+/- 5%)

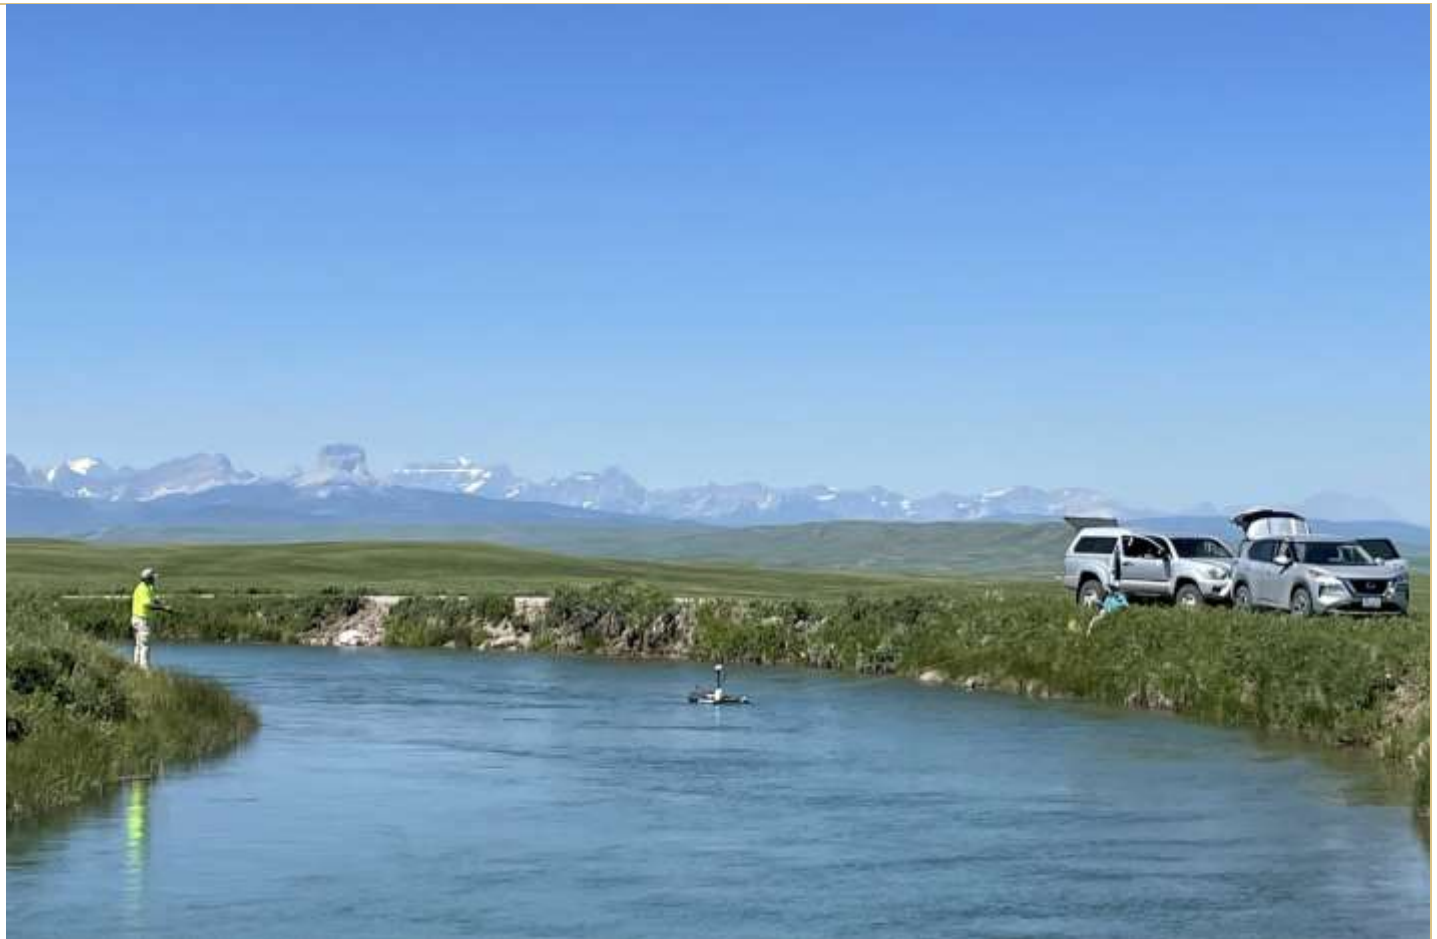
PHOTO 6. TRANSECT SM.030.0020 ON THE MAIN-LINE CANAL, JUNE 28, 2021

<i>Location Description</i>	Approximately 1000 feet upstream from Drop #1, at Hudson Bay Divide
<i>Geographic Coordinates</i>	48° 59' 41.63" N 113° 4' 53.45" W
<i>Cross-Section Description</i>	Cobbles set in soil, good depth and velocity distribution in cross section, no submerged vegetation noted; narrower, with a smooth water surface
<i>Stability Monitoring</i>	A reference gage (OSS) and recorder data are available at the streamflow gage near the St. Mary Siphon intake; steady-state conditions were verified by stable recorded gage heights of 7.53 feet during the four ADCP measurements.
<i>Reach Characteristics</i>	The ditch upstream and downstream from the transect location comprised primarily silts and clay. Bank vegetation minor emerging grasses. The location was selected to close out the loss assessment on sub-reach 3 of the St. Mary Canal.
<i>CMM#1-4 (cfs)</i>	584, 589, 588, 584
<i>Mean Discharge (cfs)</i>	586

<i>Accuracy Rating</i>	Measurements field rated good (+/- 5%)

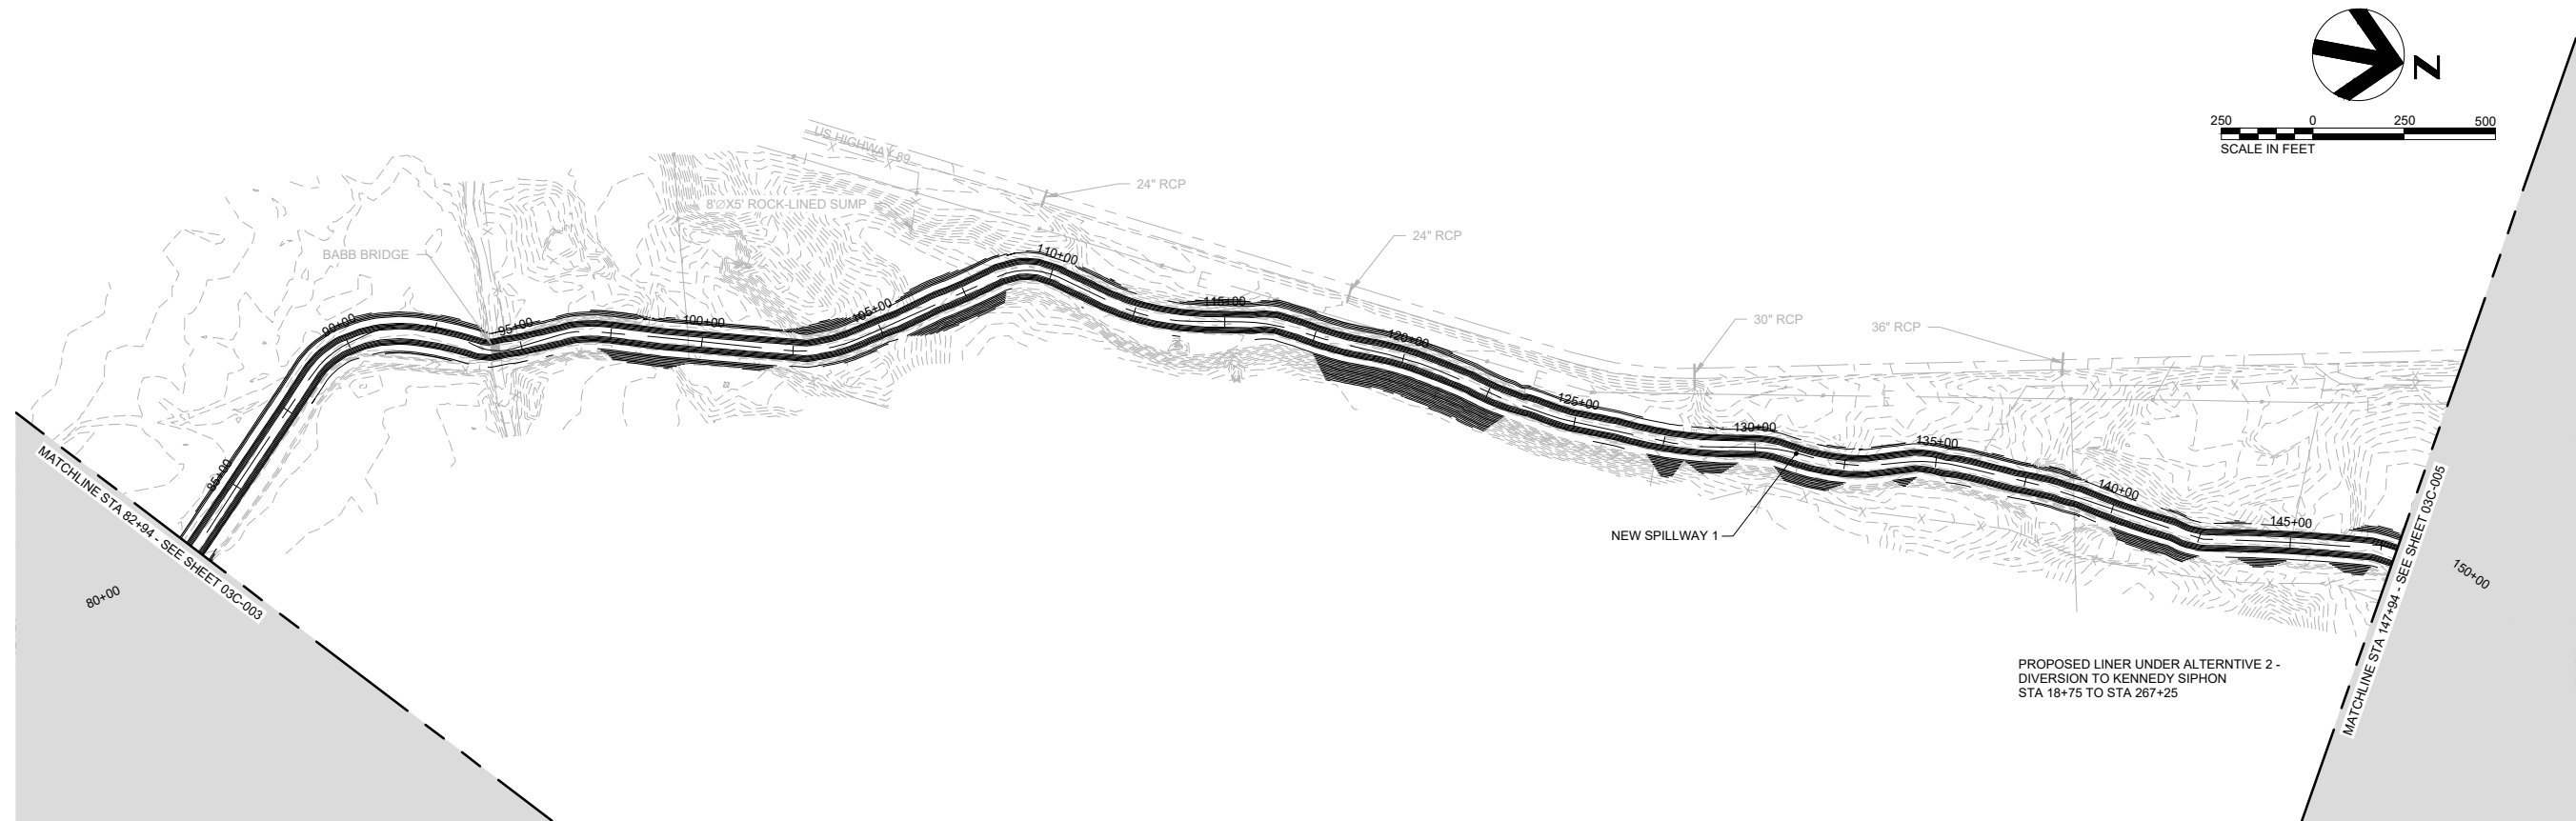
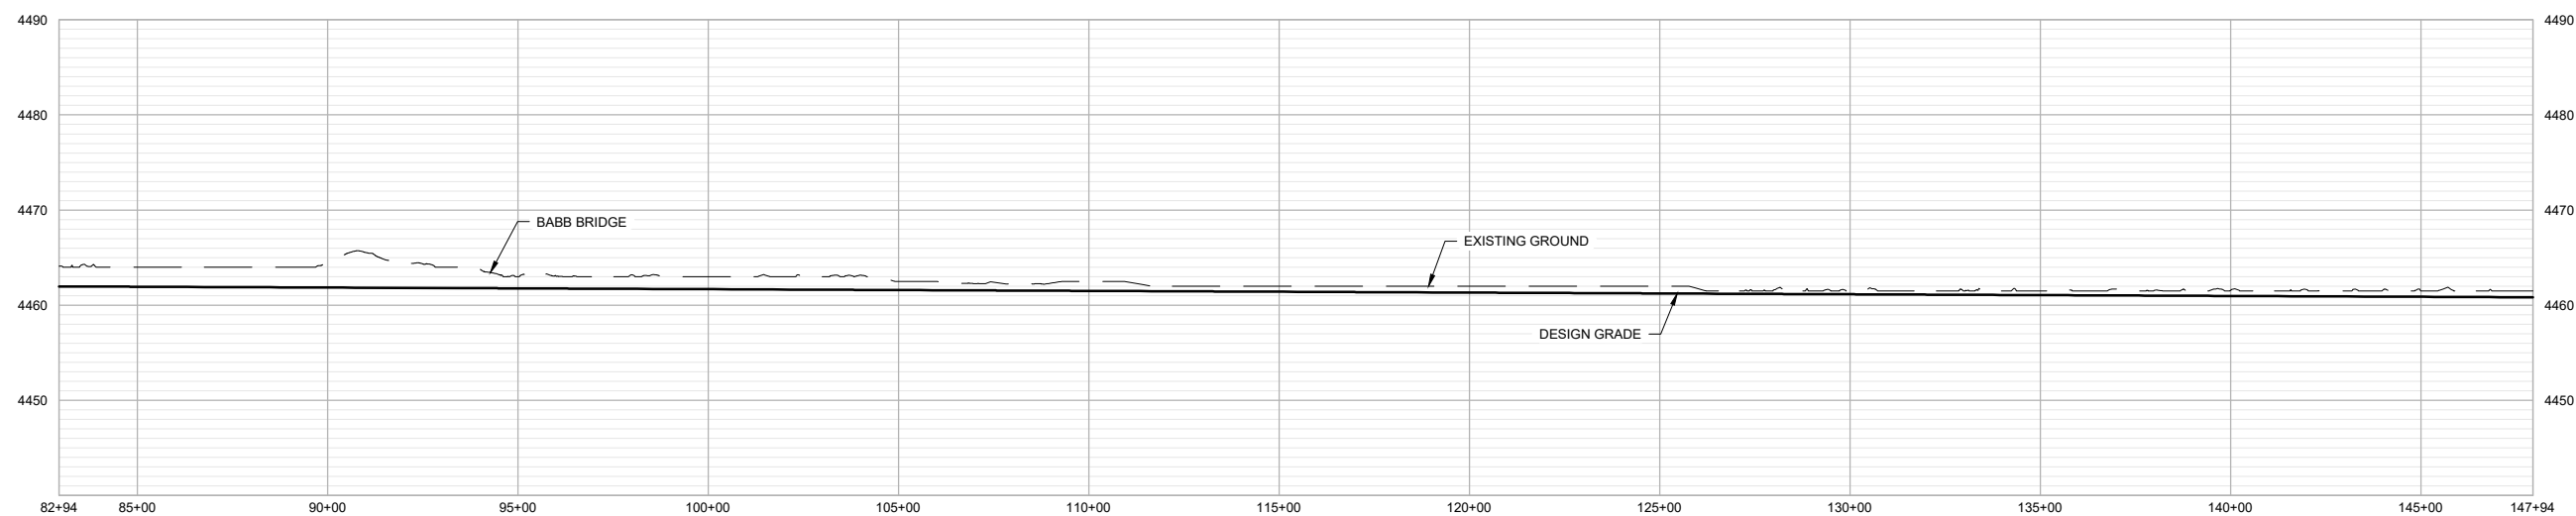
PLAN VIEW
SCALE: 1" = 250'
CONTOUR INTERVAL = 0.5 FT

- NOTES:
1. PLAN SHEET FOR ALTERNATIVE 2 AND ALTERNATIVE 3.
 2. ALTERNATIVE 2: LINER TO BE INSTALLED ON THE FIRST 9 MILES OF CANAL.
 3. ALTERNATIVE 3: NO LINER TO BE INSTALLED

PROFILE VIEW
HORIZ SCALE: 1" = 250'
VERT SCALE: 1" = 20'

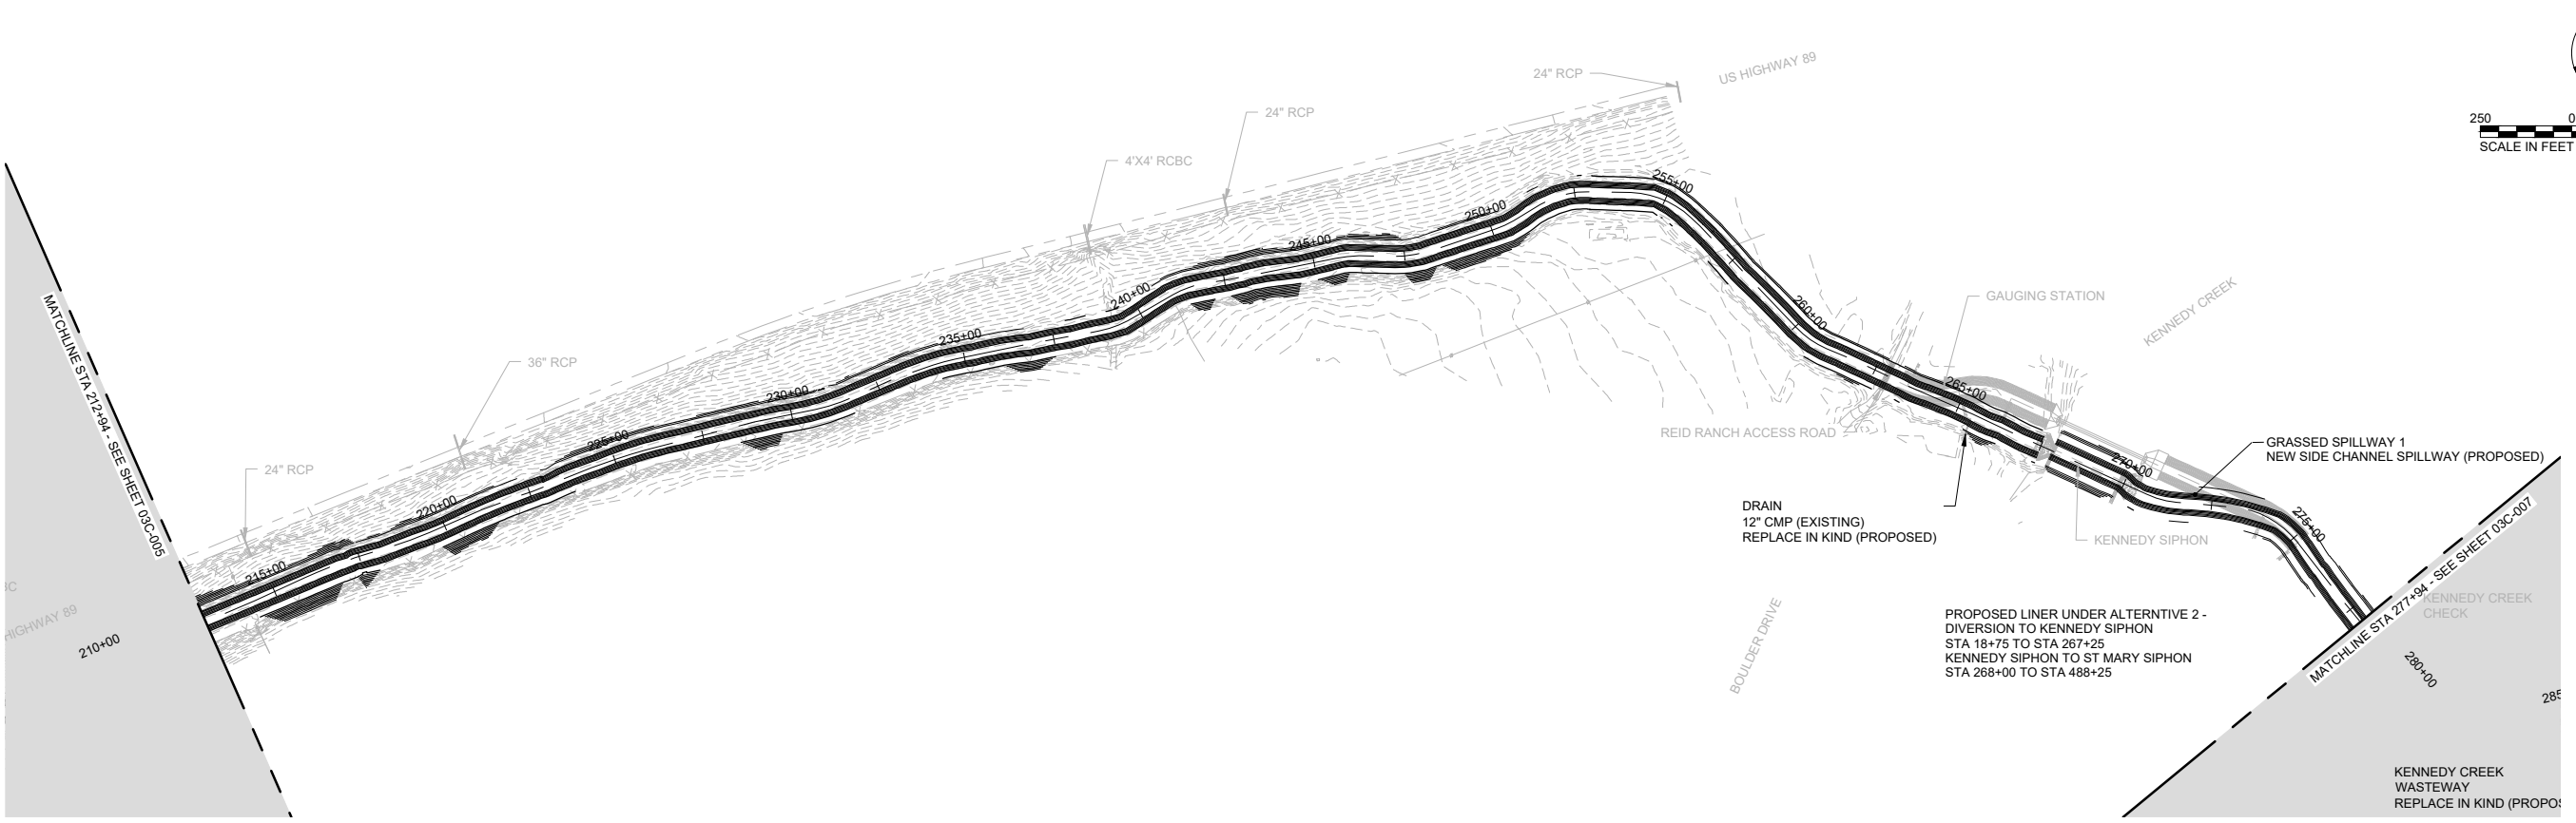
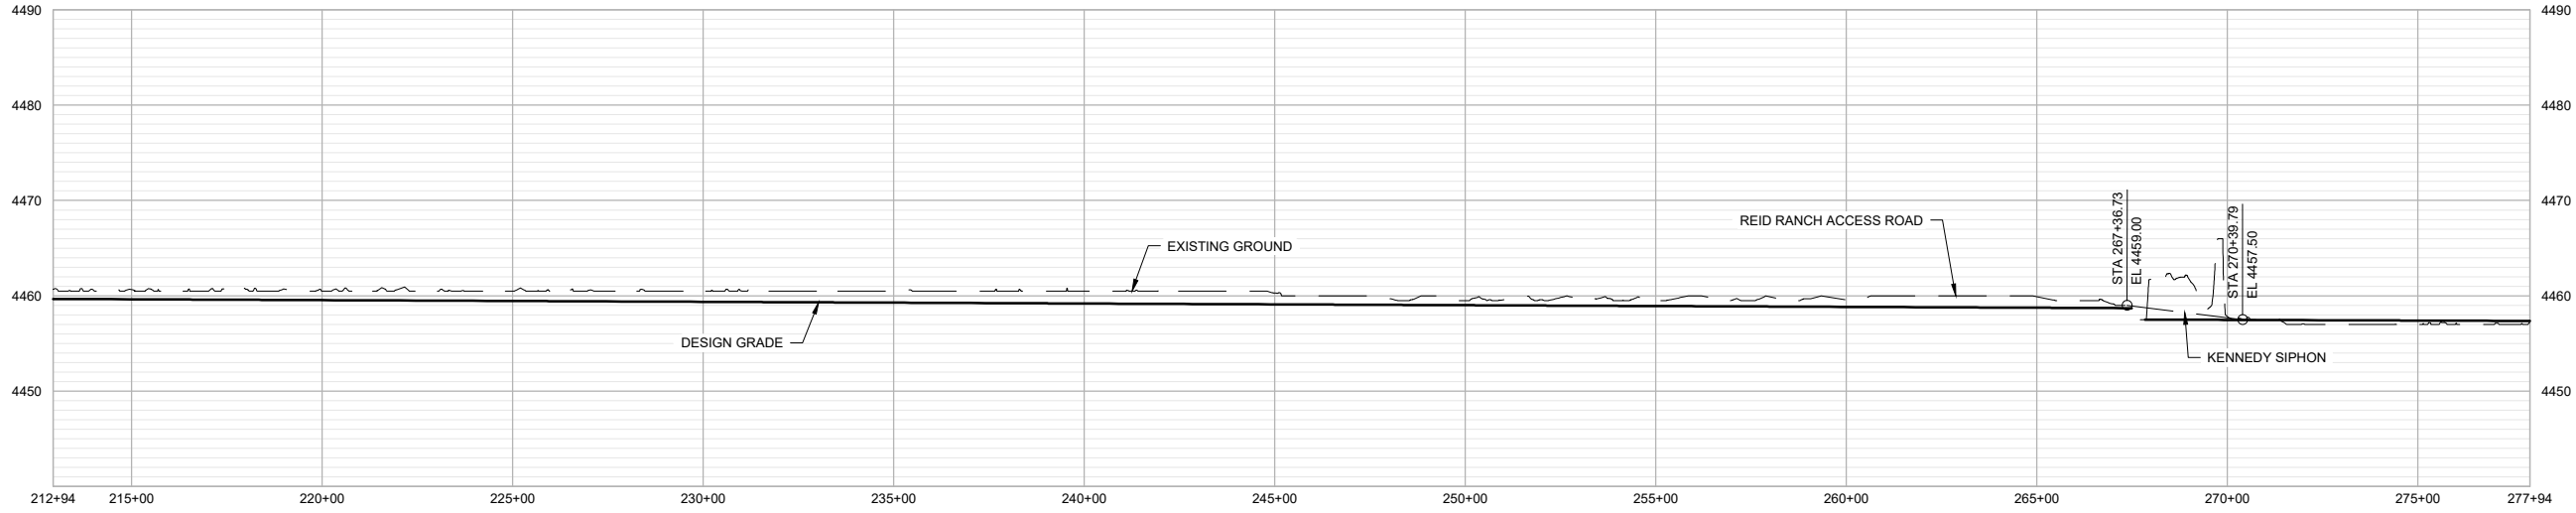
SHEET
03C-006

PLAN VIEW
SCALE: 1" = 250'
CONTOUR INTERVAL = 0.5 FT

- NOTES:
1. PLAN SHEET FOR ALTERNATIVE 2 AND ALTERNATIVE 3.
 2. ALTERNATIVE 2: LINER TO BE INSTALLED ON THE FIRST 9 MILES OF CANAL.
 3. ALTERNATIVE 3: NO LINER TO BE INSTALLED

PROFILE VIEW
HORIZ SCALE: 1" = 250'
VERT SCALE: 1" = 20'
