Appendix E. Other Supporting Information

ST. MARY CANAL

WATER LOSS ASSESSMENT

Prepared by
Farmers Conservation Alliance

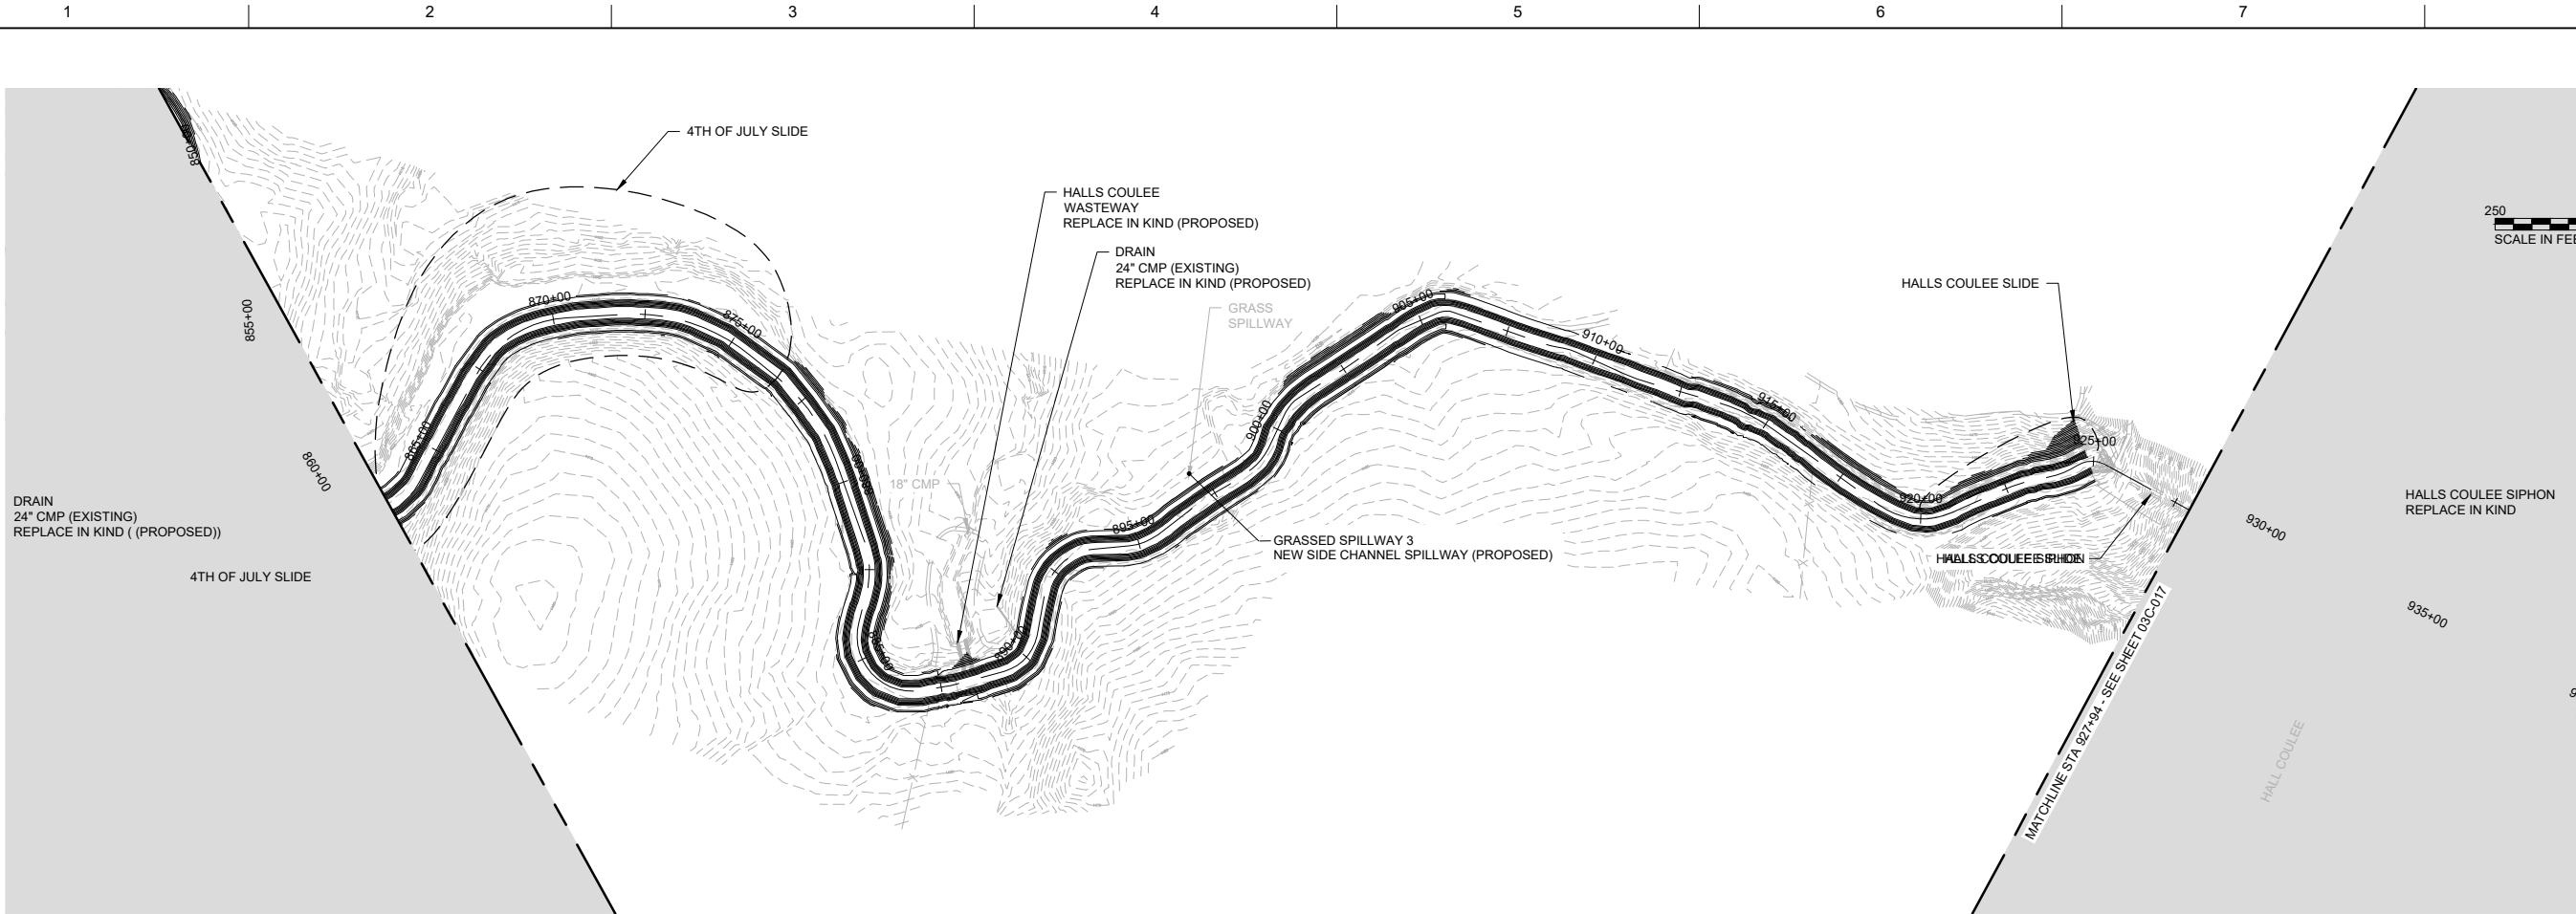
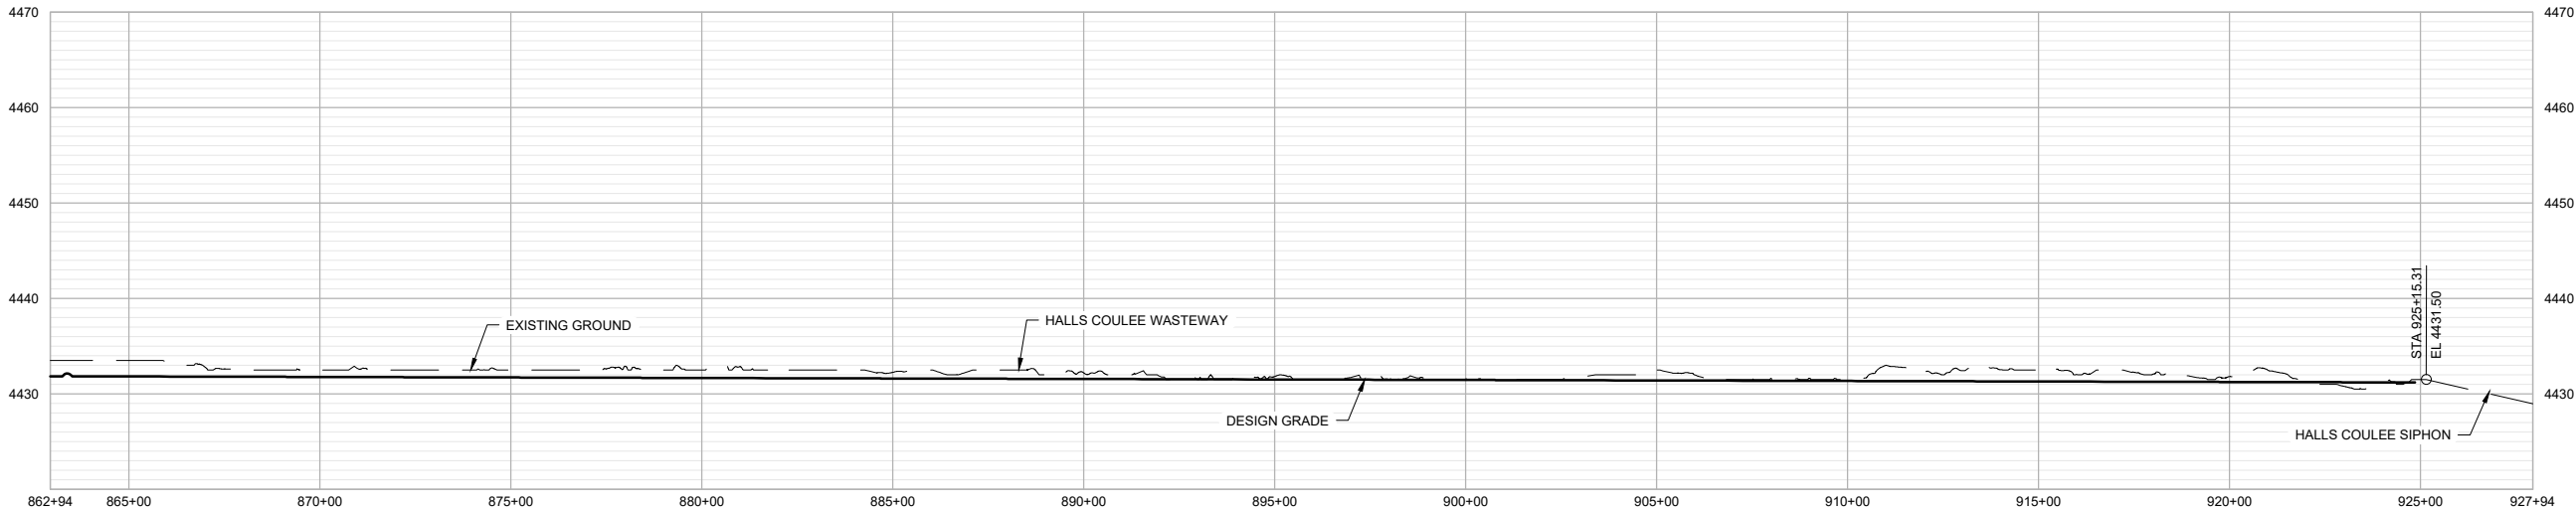
SHEET
03C-016

PLAN VIEW

SCALE: 1" = 250'
CONTOUR INTERVAL = 0.5 FT

NOTES:
1. PLAN SHEET FOR ALTERNATIVE 2 AND ALTERNATIVE 3.

PROFILE VIEW

HORIZ SCALE: 1" = 250'
VERT SCALE: 1" = 20'

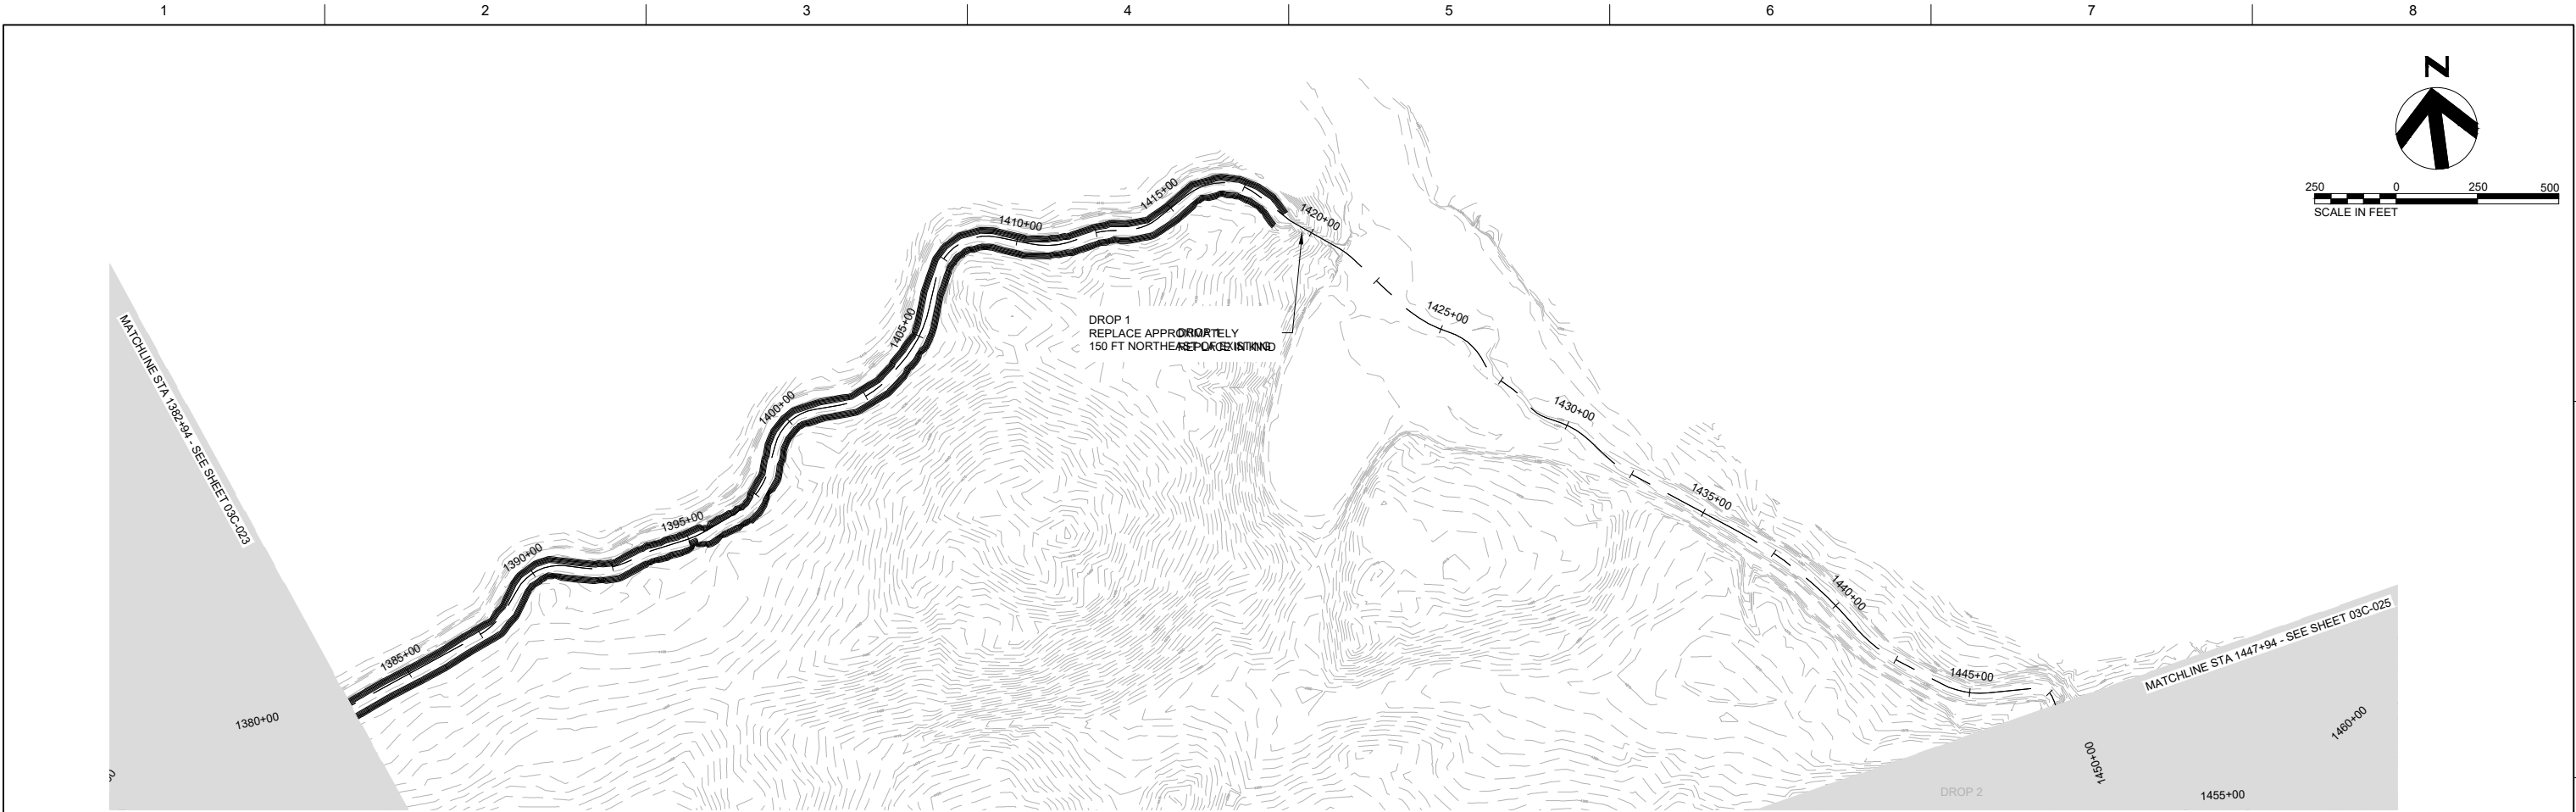
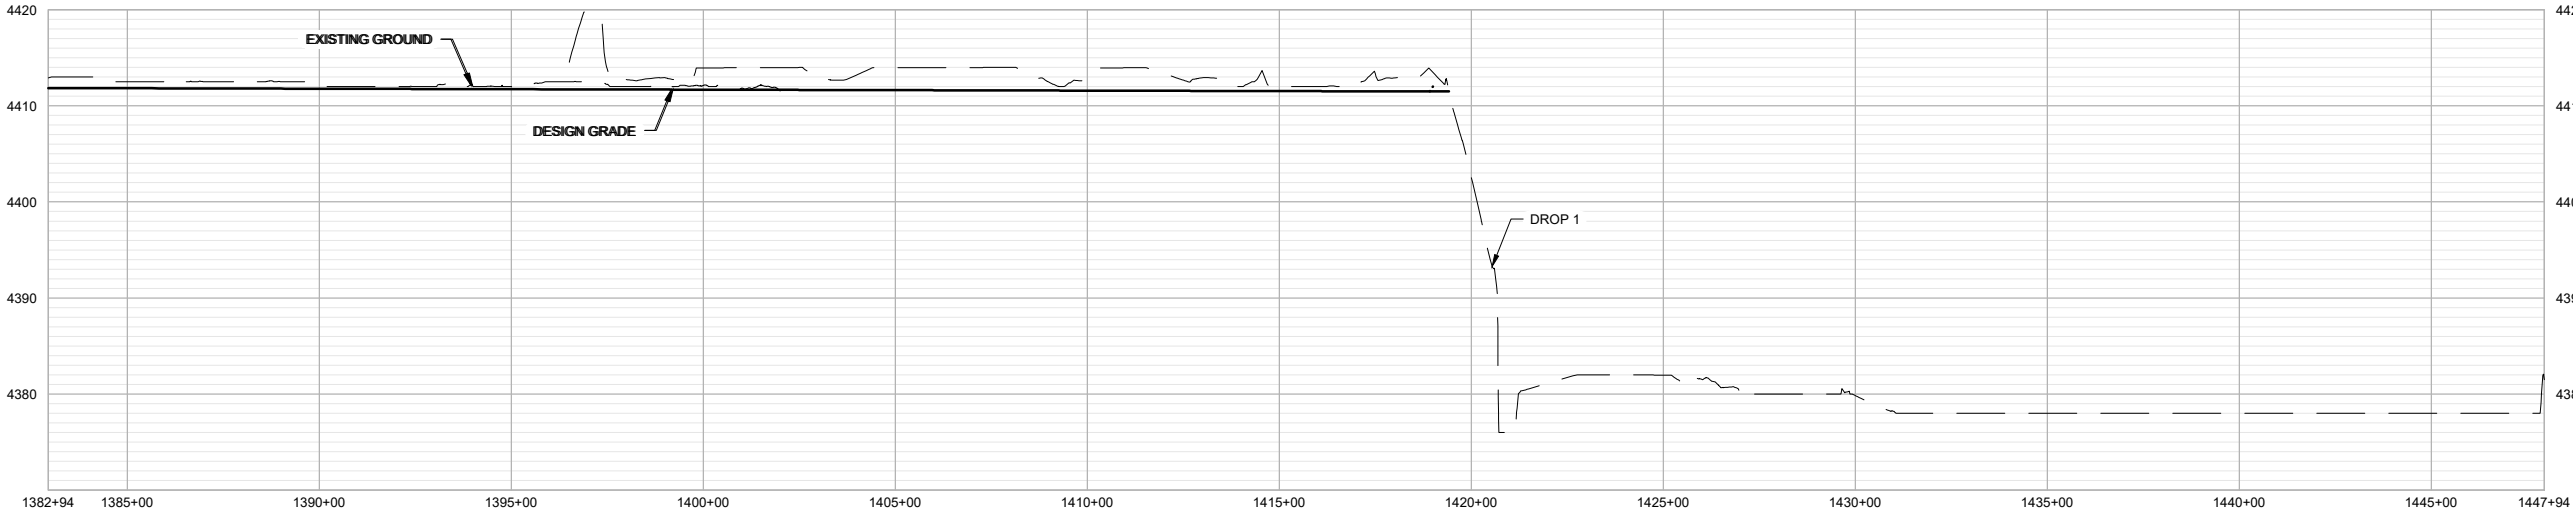
SHEET
03C-024

PLAN VIEW
SCALE: 1" = 250'
CONTOUR INTERVAL = 0.5 FT

NOTES:
1. PLAN SHEET FOR ALTERNATIVE 2 AND ALTERNATIVE 3.

PROFILE VIEW
HORIZ SCALE: 1" = 250'
VERT SCALE: 1" = 20'
